1992 Ship Production Symposium Proceedings

Paper No. 2A-2: Integration of Measurements and Maneuvering Technologies Used to Modify Caisson

Integration of Measurements and Maneuvering Technologies Used to Modify Caisson

**Joseph Krulikowski, Member, Peter Sparacino, Visitor, and
Anthony Giordano, Visitor, Philadelphia Naval Shipyard**

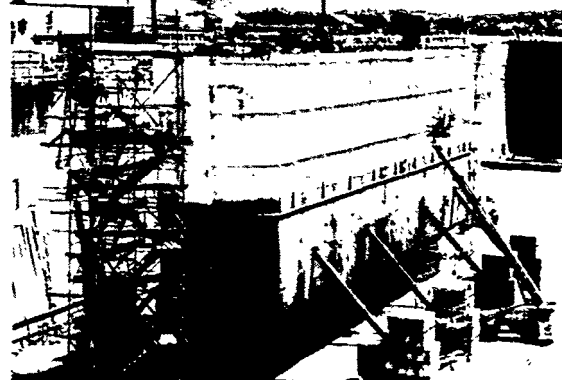
Figure 1.
New York Shipbuilding Corp. Caisson

A new caisson was estimated to cost over 4 million dollars, which exceeded the repair budget. Fortunately there was a large caisson on the base which was built by the now defunct, New York Shipbuilding Corporation (NYSC) Figure (1). It had been in service in Camden, New Jersey, for a special drydock used in the construction of the USS KITTY HAWK (CV63) in the mid 1950's. Because the caisson was stored in fresh water and had only limited use at NYSC, it was in virtually new condition. The overall dimensions of the caisson, with the exception of the length (8.38 m, 27.5 ft longer) were very similar to the original caisson. Its all welded construction made it easy to modify.

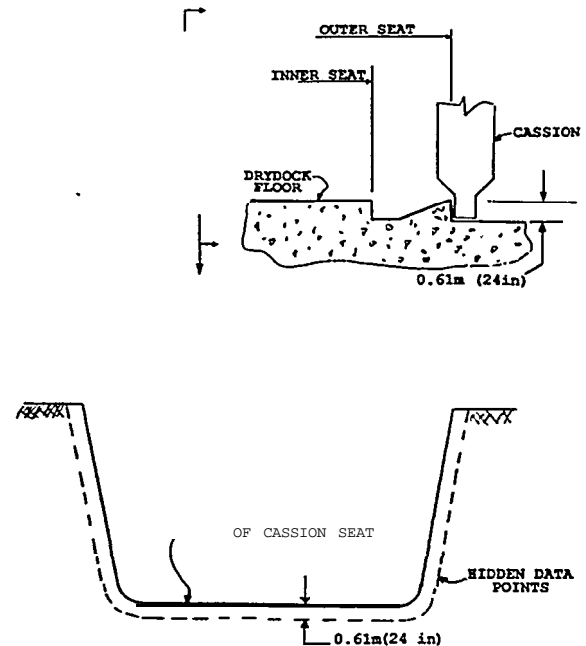
Figure 2.
Drydock NO.3 Opening

The first task for the measurement group was to provide data of the existing drydock opening (figure 2). Determination of theodolite positioning was the first concern. Placing the instruments between the inner and outer seat was eliminated for two reasons. First, a limited sight distance and very poor geometry between the theodolites and the data points impeded the accuracy. Second, with the existing caisson continuously leaking and the readings taken in the winter months, very hazardous safety conditions existed in this area with partial freezing of standing water. It was then determined that the theodolites would have to be located on the drydock floor. This created a situation where most of the data points would be hidden from sight (figure 2).

Hidden points were captured using a hidden point stick which is a targeted measured rod. By sighting the targets of the rod the theodolite system can automatically interpolate for the hidden point using the software (hidden point routine) provided with the system. Data for the drydock seat area were taken at various stations with two points per station. One representing the upper edge of the seat, which was visible and the other representing the bottom corner which was hidden. Points were taken at four stations along each side. Also,

points were taken at 15 stations in the radius area, because it was critical for fit.

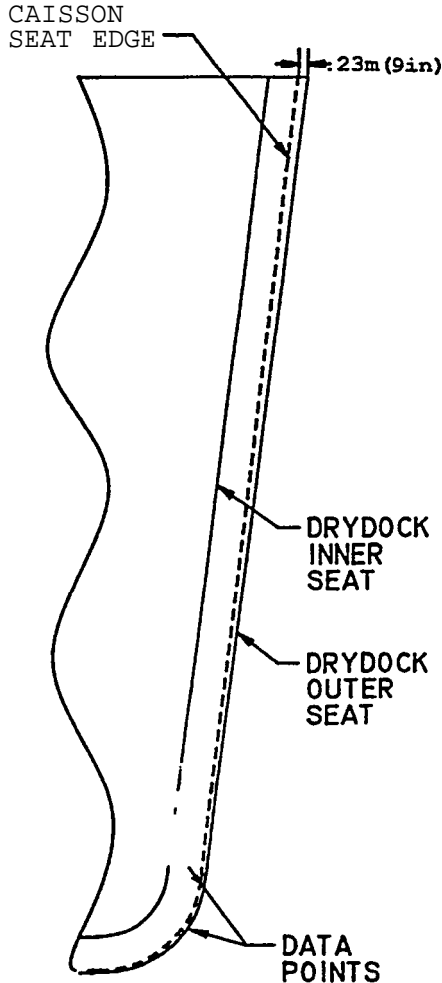
FIGURE 3.

Data taken from the survey was transferred (using a 5 1/4" floppy disc) directly into the shipyard CAD system. This allowed viewing all the data taken in three dimensions. By using curve fitting techniques, an accurate picture of the seat of the caisson and the drydock opening could be obtained. Figure 3 shows a CAD overlay of some measurement data taken.

CAD OVERLAY OF THEODOLITE DATA

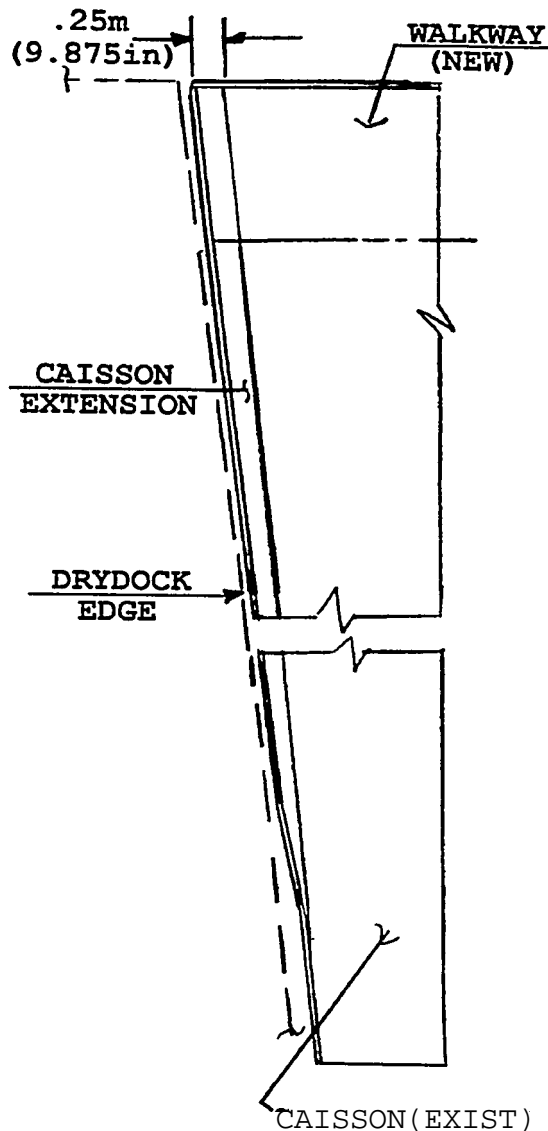
Figure 4.
Caisson Final Dimensions

Several different scenarios were evaluated. The most cost effective one was to modify the caisson asymmetrically by adding structure to one side only. This would make the clearance different at the ends if the caisson were positioned at the centerline of the drydock. But the clearance would still be within allowable tolerances if the caisson were shifted to one side or rotated 180 degrees. By jogging the seal about 6.1 meters (20 feet) from the base and removing 8.38 m (27.5 ft) from the center of the caisson we were able to meet all dimensional clearance criteria. Final dimensions are shown in Figure 4.

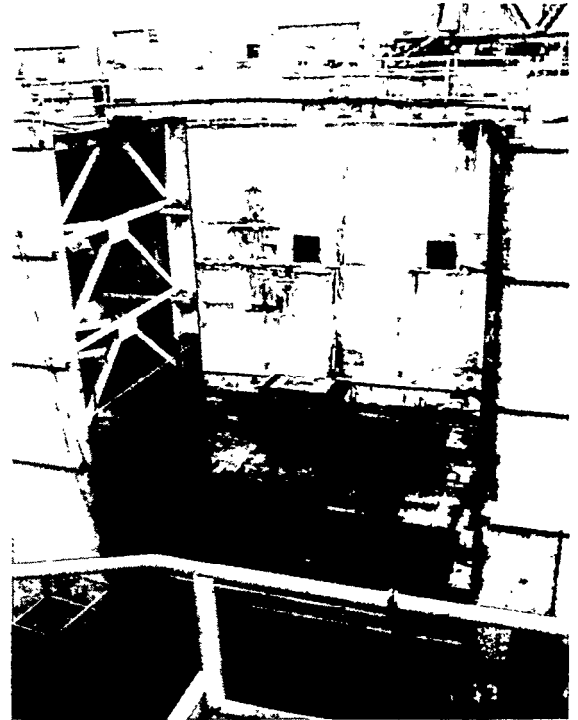
Figure 5.
Steel Removal, Center Section

between the two halves of the caisson. Shipfitters and welders worked to remove the large portions of plating and beams from the center section (Figure 5).

The area of steel removed was about 8.38 m (27.5 feet) long, 10.67 m (35 feet) high and 6.1 m (20 feet) wide across the top.

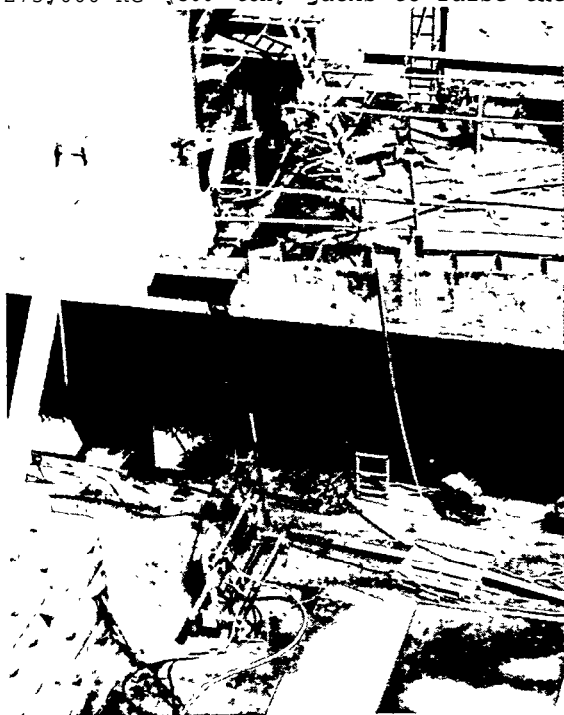
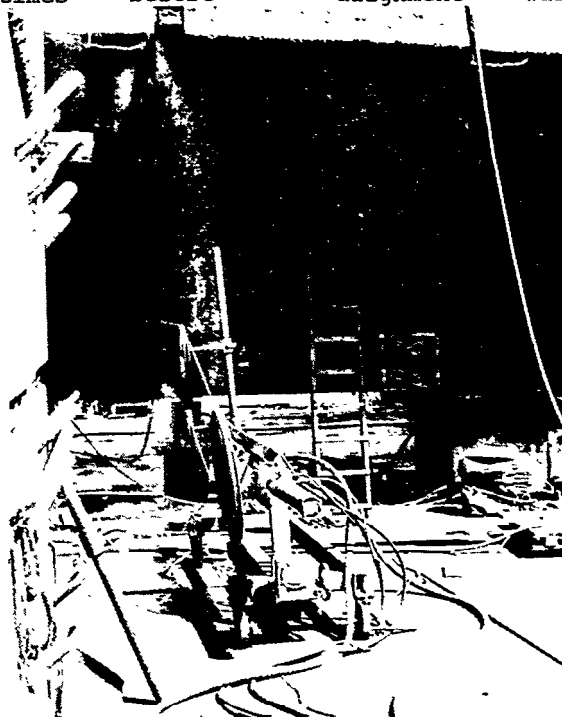
The bottom portion of the casisson contained a large amount of concrete used mainly for ballast. A concrete cutting company was tasked to make one cut at each end of the center section so that shipyard riggers could "roll" the loose wedge of concrete out of the way (Figure 6 and 7). The wedge removed was about 8.38 m (27.5 feet) long by 6.1 m (20 feet) wide by 3.35 m (11 feet) high and it weighted about 250,000 KG (275 short tons). The cutting of the concrete was accomplished using a diamond strand blade which runs through a main drive assembly around the concrete to be cut and back through the assembly. Each cut took about 10 hours.

Figure 6.
Concrete Cutting; Top View

Figure 7.
Concrete Cutting; Side View

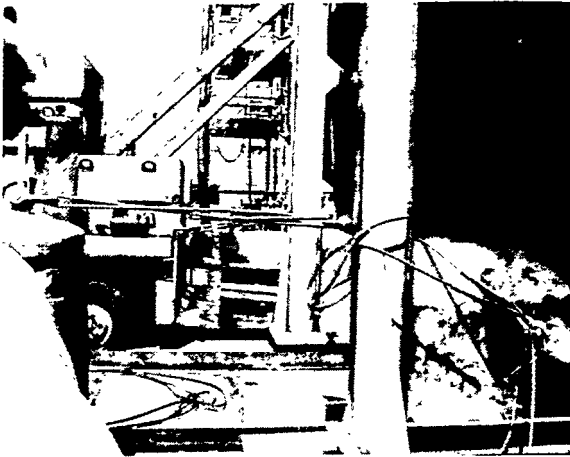
Figure 9.
Rigging For Concrete Removal

Chain falls were connected between the keel blocks and the temporary supports to allow riggers to pull the section from between the two halves of the caisson (Figure 9). This process took about six hours.

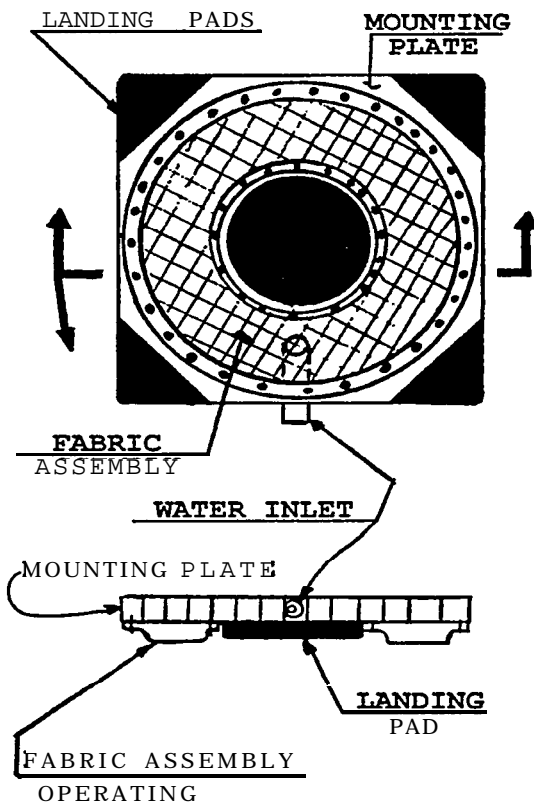
Figure 10.
Water Film Castor

The castors operate on a water film created under the castor by water leaking from the bottom of a diaphragm (Figure 10).

This allows the entire castor/caisson to "float" just like a glass filled with fluid on a wet smooth surface. The castors are flexible, so they could accommodate the lack of flatness of the

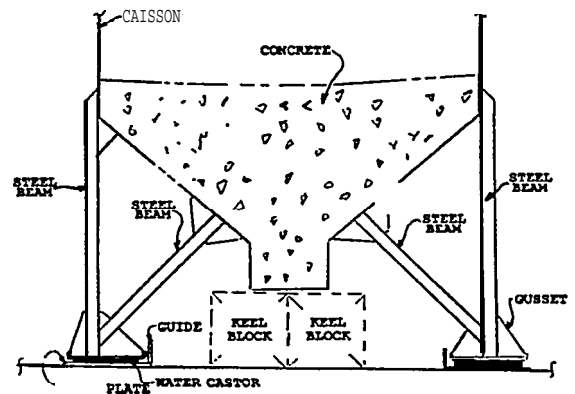
Figure 11.
Tempoary Supports For Floating Half of Caisson

The castors were rented with a representative from the vendor providing technical characteristics such as load capacity, friction factors, surface slope, and water supply. Using this information, temporary supports made of steel I beams and plates were designed. Each support was fabricated out of three I beams spaced like a tripod, over each castor to handle any rotations (Figure 11).

In this way the lifting force at the center of pressure of the castor, would remain stable in the area defined by the supporting legs. Calculations showed that a total of 20 castors would be required providing a capacity of 725,750 kilograms (1.6 million pounds). The section to be moved was 589,670 kilograms (1.3 million pounds) and the center of gravity was calculated to be 3.05 m (10 feet) up from the bottom. The castor model chosen was by AERO-GO and its designation was 4K48HDL. It was 1.22 m (4 feet) by 1.22 m (4 feet) by 0.07 m (2.75 inches) thick with a lift of 0.08 m (3.0 inches). The castors were placed between the temporary

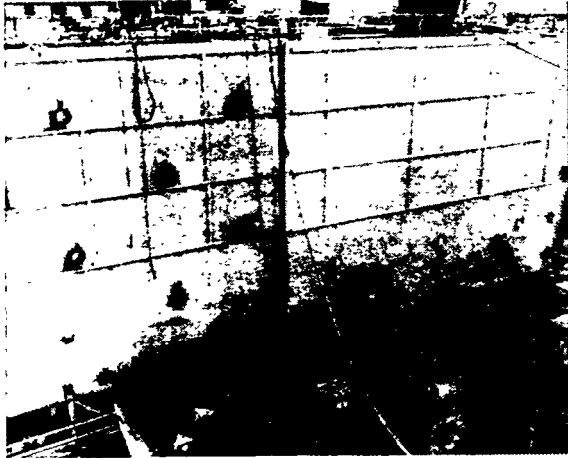
Figure 12.
Final Position of Caisson Halves

A guide track was installed along the path, laid on both sides of the caisson, to keep the caisson from "floating" off the steel path. In addition, guide wires were placed from the top of the caisson to tiedown fixtures at the top of the drydock to provide additional control. The floating section of the caisson was pulled to the stationary section by using chain falls. The final position of the two halves are shown in figure 12.

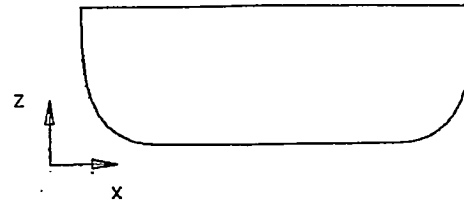
POINT 1		POINT 2	
	DESIGN	MEASURED	DESIGN	MEASURED
X	0.0	0.0	39.61M (1559.501N)	39.63M (1560.1071N)
Y	0.0	0.0	0.0	0.005M (0.19271N)
Z	15.11M (595.001N)	15.13M (595.611N)	15.11M (595.001N)	15.12M (595.24621N)

TABLE 1. DESIGN DIMENSIONS VS. MEASURED DIMENSIONS
